Recent endwinding vibration problems in air-cooled turbine generators

Joe KAPLER, John LETAL, Mladen SASIC, Greg C. STONE
Iris Power - Qualitrol
Canada

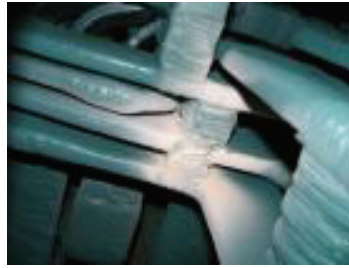
Figure 1: Winding bar insulation abrasion at support ring

All of these may have resulted from the need for manufacturers to reduce cost in response to competitive pressures. Figures 1 to 4 show examples of endwindings that have developed specific local damage to insulation fretting due to local natural frequencies. All are from 2-pole air-cooled turbine generators rated <200 MVA. Note that often such problems occur on the connections between the line end bar and the circuit ring buses (Figure 2). Figure 5 shows more global endwinding vibration. Fretting is when one component moves relative to another and results in a white powder due to abrasion of the insulation. When mixed with oil, the white powder becomes black or brown, and is often called "greasing" (Figure 3).

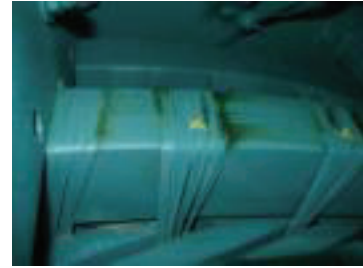
Figure 2: Insulation abrasion (dusting) at circuit rings

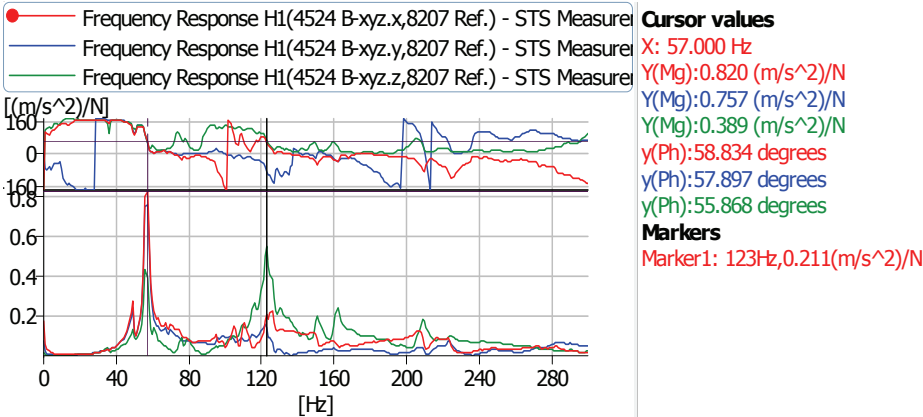
Figure 7: Bump test result from the endwinding of a 60 Hz 2-pole turbine generator. The upper plot is the phase angle of the response while the lower plot is the normalized amplitude of the response in terms of acceleration per Newton of impact force. Unfortunately, there are significant resonant peaks at 60 and 120 Hz on this machine, and significant fretting was found. The three lines represent vibration in the radial, circumferential and axial directions.

- A Fast Fourier Transform (FFT) type of spectrum analyzer that can respond to frequencies up to about 10 kHz to simultaneously capture the force input and the three accelerometer responses producing frequency response transfer functions for analysis. Figure 7 shows a plot of the normalized acceleration as a function of frequency.

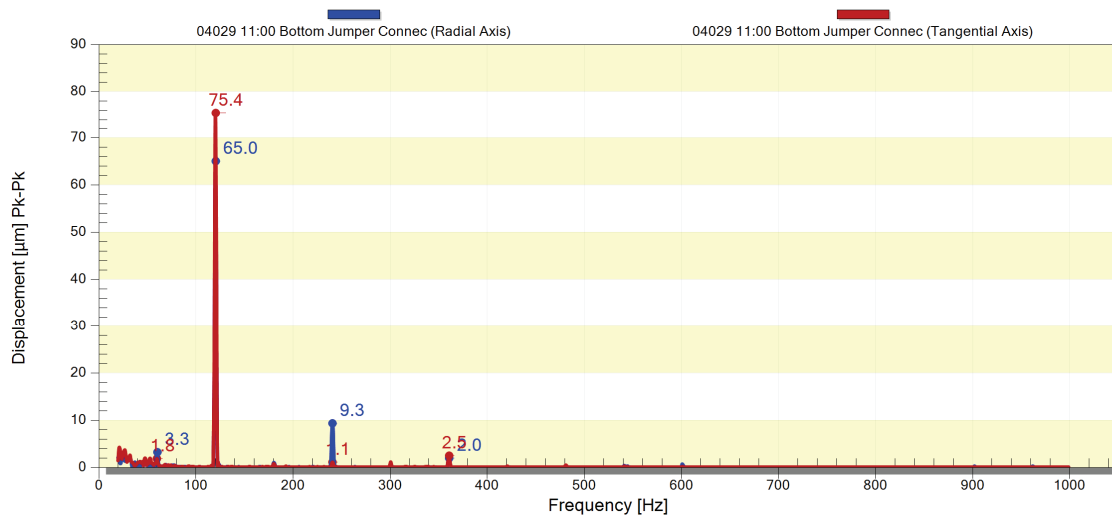
'STG-3' - Displacement Spectrum

Overall Displacement 106.3
Tue, 15 Jan 2013 19:45:16 GMT ID#219
Comment: Stator Current = 4.3kA, Winding Temperature = 64degC

Figure 8: Displacement (0 to 90 μm) vs. frequency (0 to 1000 Hz) for a two pole, 60 Hz turbine generator. Note that the 120 Hz response (due to magnetic forces) is higher than the rotational speed forces at 60 Hz caused by stator frame vibration.

Most instrumentation outputs the peak acceleration, peak velocity, and/or peak-to-peak displacement. To date, however, most of the published data are in terms of displacement (μm peak-to-peak). Displacement is a measure of the distance moved from the initial position and emphasizes low frequencies (Figure 8). The only frequencies that should normally be detected are at rated speed and $2f$. It would be unusual for any other frequency to be detected unless there are high power frequency harmonics or the windings are very loose resulting in impacts between components.
